# **NASA Independent Review Team**

## **Orb-3 Accident Investigation Report**

### **Executive Summary**

**Date of Event: October 28, 2014**

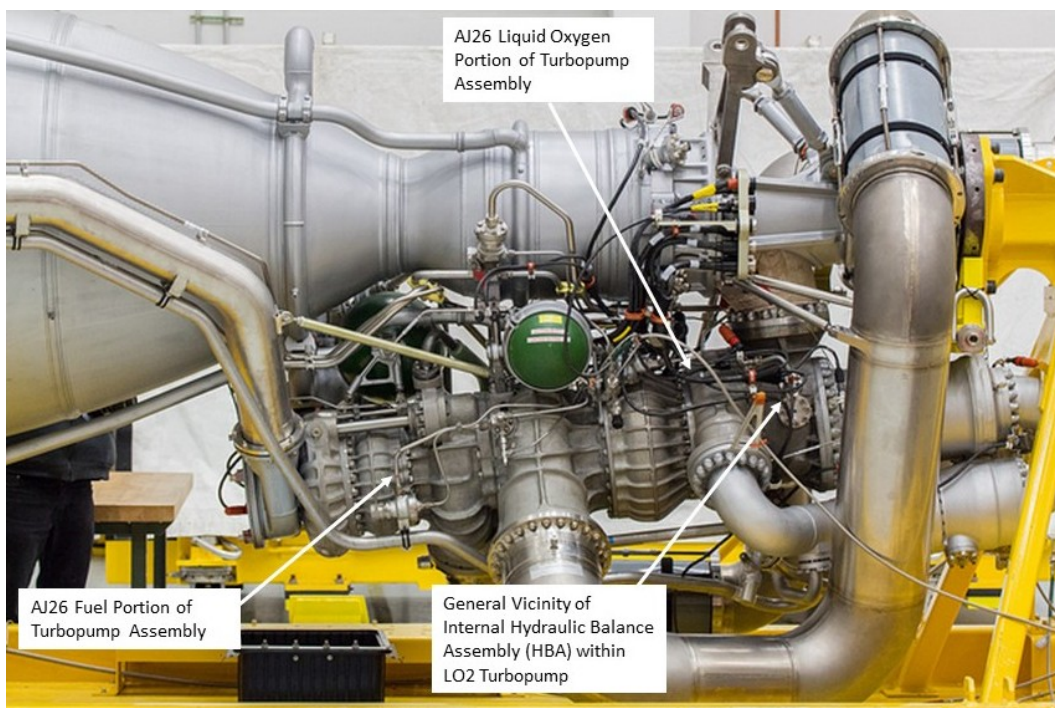
Figure 3. AJ26 Engine on Transportation and Processing Skid

The IRT performed detailed analysis and review of Antares telemetry collected prior to and during the launch, as well as photographic and video media capturing the launch and failure. Based on this analysis, the IRT determined that the proximate cause of the Antares launch vehicle failure was an explosion within the AJ26<sup>2</sup> rocket engine installed in the Main Engine 1 position. Specifically, there was an explosion in the E15 Liquid Oxygen (LO2) turbopump, which then damaged the AJ26 rocket engine designated E16 installed in the Main Engine 2 position. The explosion caused the engines to lose thrust, and the launch vehicle fell back to Earth and impacted the ground, resulting in total destruction of the vehicle and its cargo. Figure 3 shows a single AJ26 engine stored on its transportation and processing skid. Figure 4 shows the aft end of a typical Antares launch vehicle with both AJ26 engines installed.
